Sample Radiological Report

NAME OF PATIENT: Sally Goodpatient
DATE OF REPORT: 8/15/03
DATE OF EXAMINATION: 8/14/03
REFERRING PHYSICIAN: Dr. Frequent Referral
TESTING FACILITY: NU-Best Whiplash Injury Center
INDICATIONS: WHIPLASH INJURY

Digital Motion X-ray - Cervical Spine

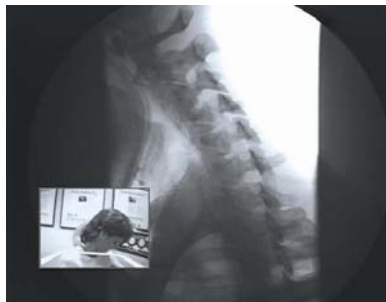
5. Right IVF flexion

5. Motion in the right and left oblique flexion projection: Shows gapping of the facet joints bilaterally at C6-C7, C7-T1.

This view examines the integrity of the capsular ligaments by observing gapping of the facet joints, located on the posterior cervical spine (C2-C7), there are five capsular ligaments on the right and the left.

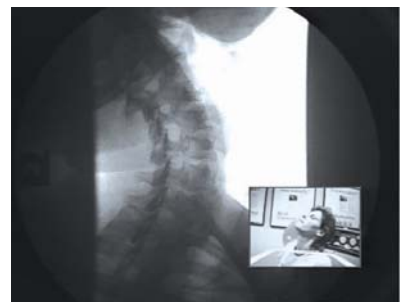
6. Left IVF oblique extension

6. Motion in the right and left oblique extension projection: Shows intervertebral foraminal encroachment on the right at C4-C5 and on the left at C3-C4.

This view examines the integrity of the capsular ligament by encroachment into the intervertebral foramen, located on the posterior cervical spine (C2-C7), there are five capsular ligaments on the right and the left.

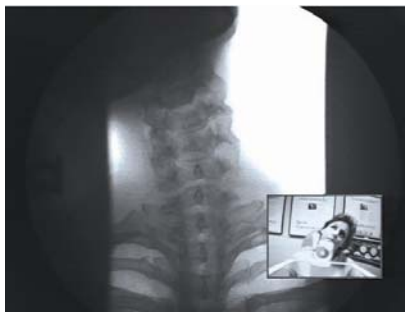
Left lateral bending

7. Motion in the A-P lateral bending projection: Is restricted bilaterally.

This view allows us to evaluate coupled motion of the spinous processes which examines facet joint integrity.

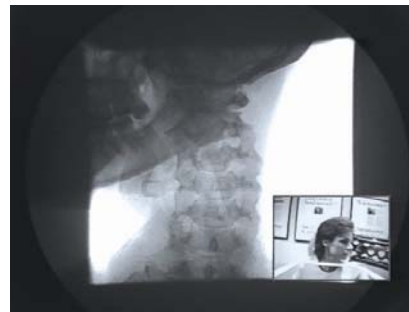
Left rotation

8. Motion in the A-P rotation projection: Is within normal limits.

This view examines the rotational range of motion between Occiput-C1-C2. Increased motion indicates damage to the alar and accessory ligaments.
